Manhole Inspection Summary

Manhole # S45I__019MH

Insp Date: **7/30/09 10:26 AM**

Location Address: **1919 GOUGH ST**

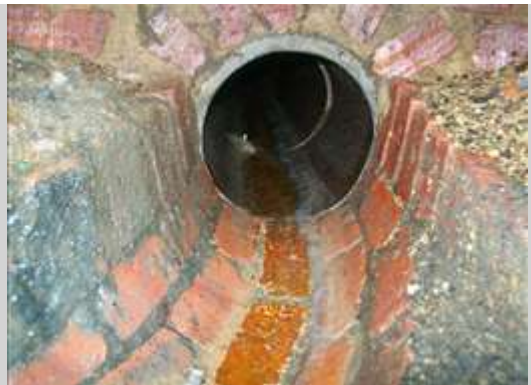
3 O'Clock Inflow

8 in. Circular Gravity Sewer
Pipe In @ 3 O'Clock

Pipe Height: **8.4** (in.) Rod and Bar (Angled)
Pipe Material: **Clay** ☐ Pipe Lined
Invert Depth: **11.25** (ft.) Flow Characteristics: **Slow**
Deposits: ☒ None ☐ Mud ☐ Sludge ☐ Debris ☐ Grease
Silt Depth: **0** (in.) Deposits Extent:
Infiltration: **None** Pipe Seal Cond: **Sound**
